Dam Report

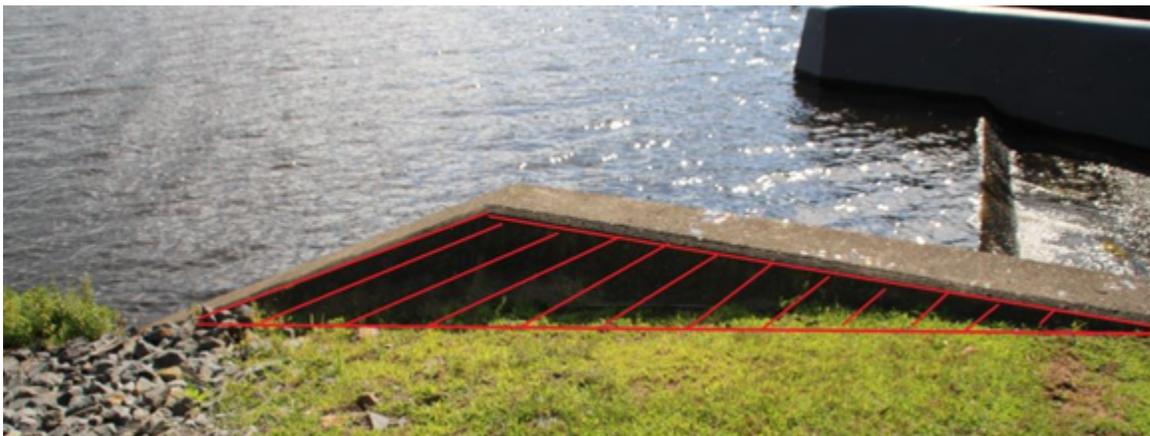
There are currently several smaller repair and or maintenance activities needing to be performed on and around the dam. These are currently on hold waiting for the final report. Of special note and concern is the removal of rocks (rip-rap) from the dam face, and throwing of rocks into the spillway. The rip-rap is the protective barrier for our dam and is vital for its structural integrity. The picture shows the depletion of rip-rap along the spillway walls.

Red lines indicate missing rip-rap. This condition is on both walls.

This is a serious problem that lowers the holding capacity of the dam in the event of a serious storm event, as well as provides a high potential for dam erosion and possible failure should the water level reach this height. Currently, the estimated cost to repair these areas is \$12,000. Debris and rocks thrown into the spillway impede flow and require removal.
