WLLA Road Committee Report July 18, 2020

Asphalt Roads - Actionable Item (See pages below for pictures)

Road side Drainage

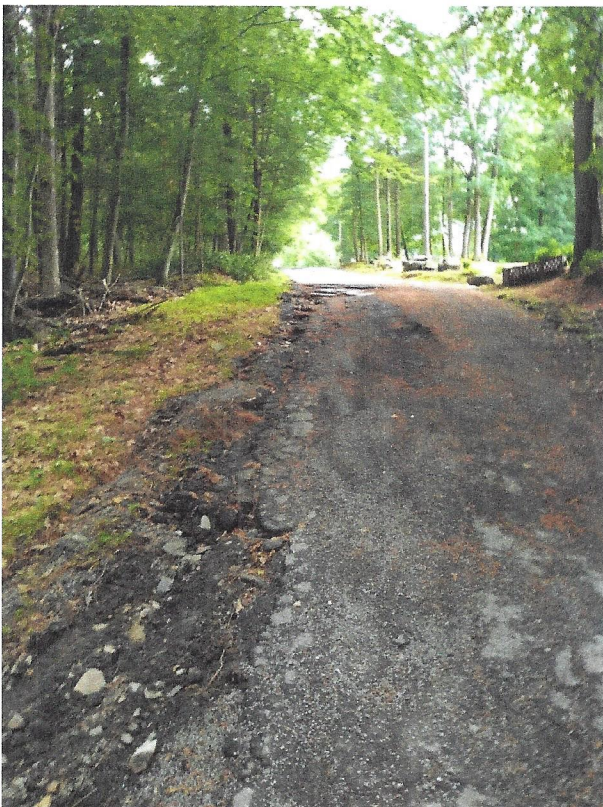
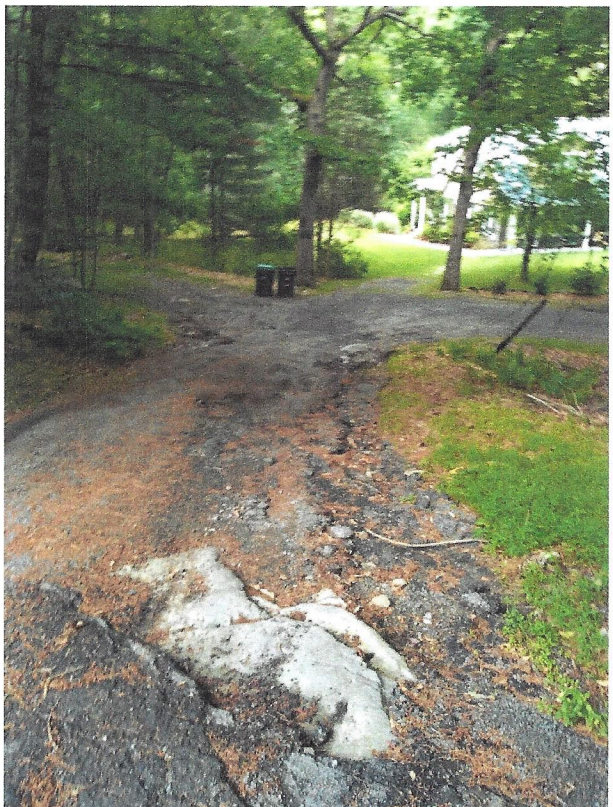
White Spruce Road Damage (caused by water)

- **Update and Action Item** – White Spruce Road damage (See pages below for pictures) -Warner Paving has submitted a bid for \$5,220 to repair and repave while pitching it so the water runs off to a right side ditch line on White Spruce from Cree to Seneca. Warner will also excavate a ditch line on right side heading towards Seneca to handle the water from the roadway so the roadway doesn't get washed out again. They will also line the ditch with 2 ½" stone to stop soil erosion. (Side note owner at 114 Cree will be paying Warner Paving an additional \$700 to have a culvert pipe put under his driveway on White Spruce. This pipe will be put in during the ditch excavation)

Recommend that Warner Paving & Excavation be awarded a contract for \$5,220 to repair and repave White Spruce from Cree to Seneca and excavate a proper ditch line including rock for soil erosion prevention.

- From 6/20/2020 report: As part of the White Spruce pavement repair project we will also need to ensure the water runs properly off the road. Michael has discussed the roadway drainage issue with the property owner of 114 Cree Road because certain upgrades on his property will need to be done to ensure we don't cause him a larger water problem than he already experiences. The property owner said he is willing to pay for the work that needs to be done to his property. It is important that both of these projects, ours and the owner's property are done simultaneously.

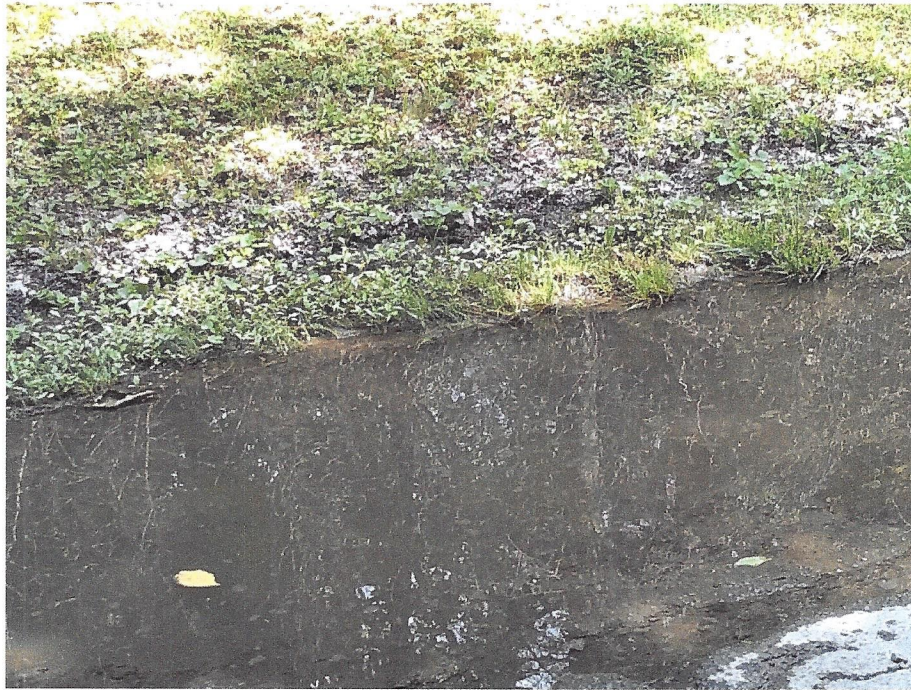
Birch between Blackfoot and Piute

Water unable to run off the roadway due to buildup of vegetation

- At the June 20, 2020, meeting it was suggested the road committee submit locations of issues and the WLLA office would notify the landowner. Michael submitted one the worst areas to the office but it may be felt by some board members that we can’t make the landowner dig a ditch. Pictures are below. A site visit at this location will show how the water runoff was never maintained in a number of years. The culvert pipes on the corners of the property appear not to have been cleaned or maintained in a number of years.

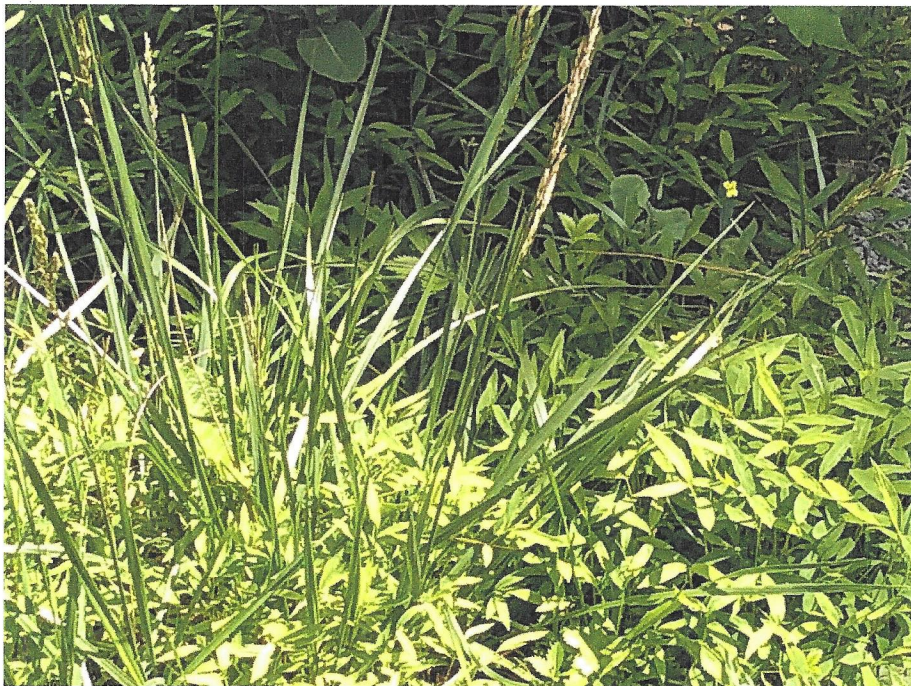
Overgrowth along road

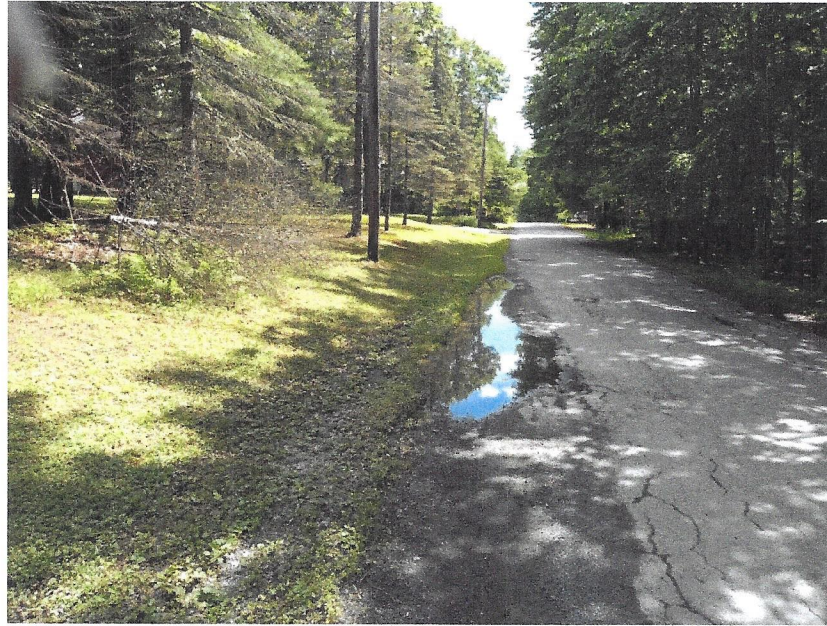
This picture was taken several days after the top picture...water still laying there but not as much as it seeps into both the ground and into subgrade of the pavement

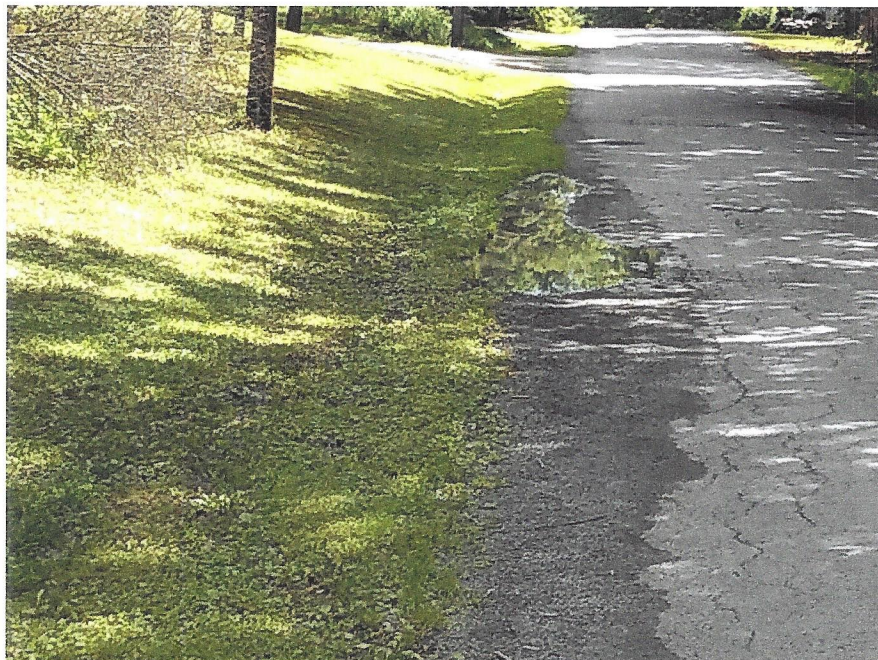
Notice the width of the roadway in the background of where the puddle is ... look at the deterioration the water is causing at this location also causes premature failure of road area next to it (see the extensive cracking)
